**Flood Control Project Maintenance
Levee Inspections**

Maintenance Issue Types Only, Levee Inspection Report By Mile - Spring 2019

Tehama County Flood Control and Water Conservation District

Waterway	Bank	Unit Miles	Inspection Start/End	Inspector
Unit No. 01 Deer Creek	Left	4.22	05/01/2019 05/01/2019	Makar Sokol

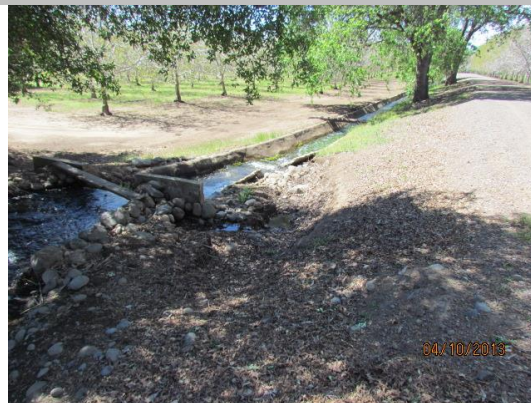
Photo 1 of 1 : SP_2019_NA0019_78_17_20190327_00005.jpg

LM Start	0.01	Rating **	M	Issue No.	17
LM End	0.01	Issue Type +	Ma	Location *	LS
Category	Earthen Levee			GPS Latitude/Longitude	
				Start	End
Item	Erosion / Bank Caving			39.973111 °	39.973111 °
				-121.980466 °	-121.980466 °
DWR ID	DWR_NA0019_01_s_2013_17				
Comment Code					
E2 : Schedule repair of erosion site prior to the next inspection.					
Inspector Comment

View of the erosion along the landside slope.

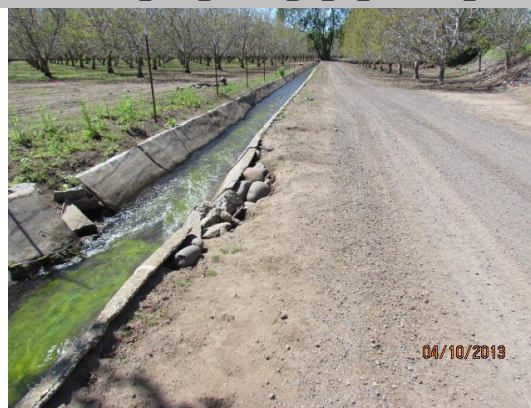
Photo 1 of 1 : SP_2019_NA0019_78_18_20190327_00006.jpg

LM Start	0.41	Rating **	A/W	Issue No.	18
LM End	0.41	Issue Type +	Ma	Location *	LS
Category	Earthen Levee			GPS Latitude/Longitude	
				Start	End
Item	Erosion / Bank Caving			39.972560 °	39.972560 °
				-121.987759 °	-121.987759 °
DWR ID	DWR_NA0019_01_s_2013_18				
Comment Code					
E1 : Note and monitor erosion site.					
Inspector Comment

View of the erosion along the landside slope.

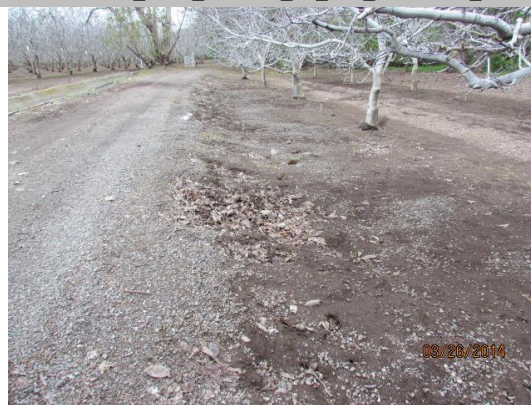
Photo 1 of 1 : SP_2019_NA0019_78_276_20190327_00020.jpg

LM Start	0.45	Rating **	M	Issue No.	276
LM End	0.45	Issue Type +	Ma	Location *	WS
Category	Earthen Levee			GPS Latitude/Longitude	
				Start	End
Item	Slope Stability			39.972377 °	39.972377 °
				-121.988559 °	-121.988559 °
DWR ID	DWR_NA0019_01_s_2014_276				
Comment Code					
S1 : Repair slope instability.					
Inspector Comment

View of the slope instability along the waterside slope.

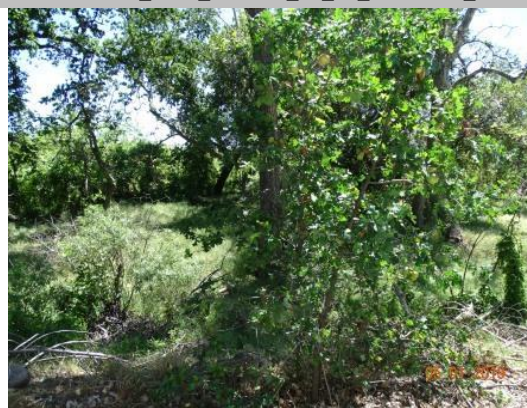
Photo 1 of 1 : SP_2019_NA0019_78_30_20190506_00063.jpg

View of a small tree on the landside toe. Spring 2019.

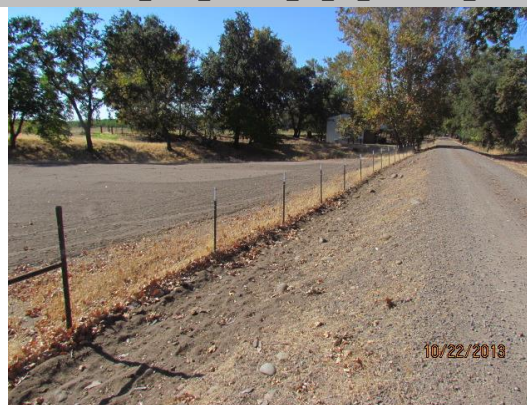
Photo 1 of 1 : SP_2019_NA0019_78_21_20190327_00009.jpg

LM Start	1.47	Rating **	M	Issue No.	21
LM End	1.47	Issue Type +	Ma	Location *	LS
Category	Earthen Levee			GPS Latitude/Longitude	
				Start	End
Item	Slope Stability			39.969702 °	39.969702 °
				-122.006975 °	-122.006975 °
DWR ID	DWR_NA0019_01_f_2013_21				
Comment Code					
S2 : Repair the levee slope damaged by foot traffic and prevent access where possible.					
Inspector Comment					
Keep livestock off levee and repair damage.

View of the erosion caused by livestock on both slopes of the levee.

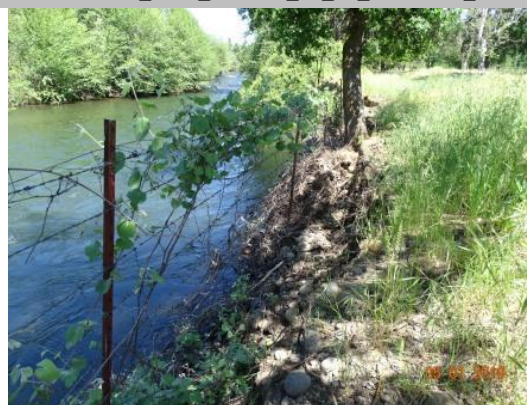
Photo 2 of 2 : SP_2019_NA0019_78_42_20190506_00065.jpg

LM Start	1.55	Rating **	A/W	Issue No.	42
LM End	1.58	Issue Type +	Ma	Location *	WS
Category	Earthen Levee			GPS Latitude/Longitude	
				Start	End
Item	Erosion / Bank Caving			39.969193 °	39.969052 °
				-122.008458 °	-122.008920 °
DWR ID	DWR_NA0019_01_s_2017_42				
Comment Code					
E2 : Schedule repair of erosion site prior to the next inspection.					
Inspector Comment

View of the erosion along the waterside toe. Spring 2019.

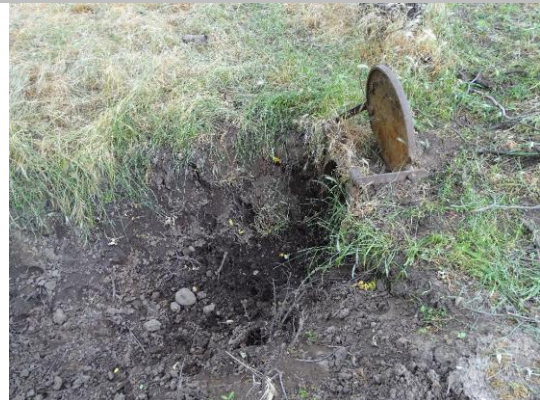
Photo 2 of 3 : UCIP_SP_2019_54006_79262.jpg

Comment Code						
Inspector Comment						
FS_ID:54006 DS_ID:20770 EP_NO: N/A Repair Type: Non-Urgent Crossing Status: Found UCIP Comments: 05/14/2019 Pipe end on WS has been cleared from sediment buildup to let flap gate close properly, but the rest of pipe is still silted inside. Flap gate was fixed and operable now. (DWR UCIP - OYakimov)10/15/2018 Flap gate on WS end stuck open. Lower part of pipe is silted that makes impossible flap gate to fully close. Needs sediment cleanup around pipe outlet on WS. (O.Yakimov - DWR)12/05/2016 Sediment buildup inside pipe (see photo) and sediment buildup on WS blocking flap gate. Crossing has been downgraded from Urgent to Non-Urgent crossing was closed on both WS and LS. (O. Magana - DWR UCIP)10/02/2013 Flapgate blocked by soil buildup. (W. Wylie - DWR UCIP) FIELD_STRUCT_DESC: 24-inch steel drainage pipe through the levee, 1.5 feet below the crown. Flap gate on the waterside (WS) toe. [Additional Reference(s): DWR Levee Log, 1992. USACE Sacramento O&M Manual Unit 509, March 1957, As-built drawings available 50-4-2394 (Station 185+40)]. FS Date: 5/14/2019 3:33:54 PM

Flap gate at WS toe

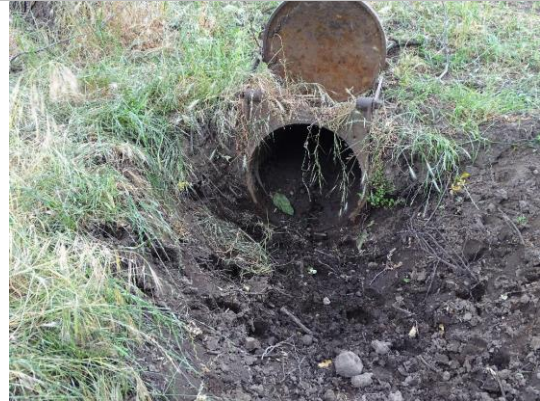
Photo 3 of 3 : UCIP_SP_2019_54006_79263.jpg

Comment Code						
Inspector Comment						
FS_ID:54006 DS_ID:20770 EP_NO: N/A Repair Type: Non-Urgent Crossing Status: Found UCIP Comments: 05/14/2019 Pipe end on WS has been cleared from sediment buildup to let flap gate close properly, but the rest of pipe is still silted inside. Flap gate was fixed and operable now. (DWR UCIP - OYakimov)10/15/2018 Flap gate on WS end stuck open. Lower part of pipe is silted that makes impossible flap gate to fully close. Needs sediment cleanup around pipe outlet on WS. (O.Yakimov - DWR)12/05/2016 Sediment buildup inside pipe (see photo) and sediment buildup on WS blocking flap gate. Crossing has been downgraded from Urgent to Non-Urgent crossing was closed on both WS and LS. (O. Magana - DWR UCIP)10/02/2013 Flapgate blocked by soil buildup. (W. Wylie - DWR UCIP) FIELD_STRUCT_DESC: 24-inch steel drainage pipe through the levee, 1.5 feet below the crown. Flap gate on the waterside (WS) toe. [Additional Reference(s): DWR Levee Log, 1992. USACE Sacramento O&M Manual Unit 509, March 1957, As-built drawings available 50-4-2394 (Station 185+40)]. FS Date: 5/14/2019 3:33:54 PM

Sediment was cleared around flap gate

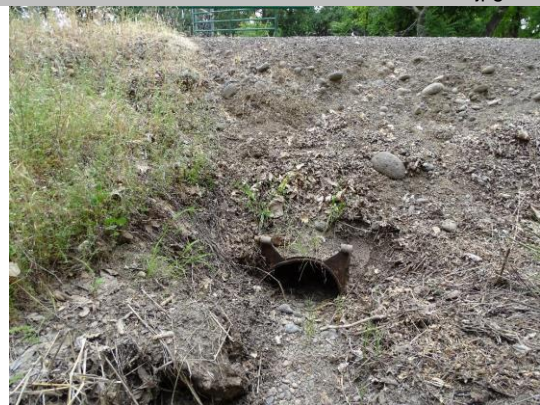
Photo 2 of 3 : UCIP_SP_2019_54008_79271.jpg

Comment Code					
Inspector Comment					
FS_ID:54008 DS_ID:20769 EP_NO: N/A Repair Type: Urgent Crossing Status: Found UCIP Comments: 05/14/2019 No change to the crossing since last inspection. (DWR UCIP - OYakimov)10/15/2018 Flapgate on WS is missing, pipe partially blocked with sediment. (O.Yakimov - DWR)12/05/2016 same as last inspection. Crossing remains "Urgent" WS opened during flood season due to damaged flap gate. (O. Magana - DWR UCIP)10/02/2013 Flapgate missing or buried on WS toe. Pipe partially blocked by soil on WS toe. (W. Wylie - DWR UCIP) FIELD_STRUCT_DESC: 24-inch corrugated metal drainage pipe through the levee, 7 feet below the crown. Flap gate located on the waterside (WS) end. A 5-foot by 5-foot concrete control structure located on the landside (LS) toe. [Additional Reference(s): DWR Levee Log, 1992. USACE Sacramento O&M Manual Unit 509, March 1957, As-built drawing no. 50-4-2394 (Station 176+10)]. FS Date: 5/14/2019 4:05:54 PM

Partially silted pipe at WS toe missing flap gate

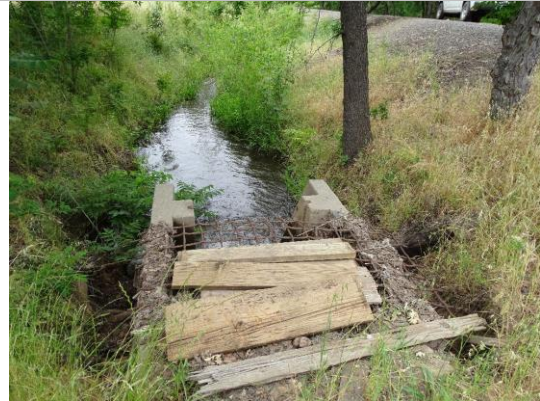
Photo 3 of 3 : UCIP_SP_2019_54008_79268.jpg

Comment Code					
Inspector Comment					
FS_ID:54008 DS_ID:20769 EP_NO: N/A Repair Type: Urgent Crossing Status: Found UCIP Comments: 05/14/2019 No change to the crossing since last inspection. (DWR UCIP - OYakimov)10/15/2018 Flapgate on WS is missing, pipe partially blocked with sediment. (O.Yakimov - DWR)12/05/2016 same as last inspection. Crossing remains "Urgent" WS opened during flood season due to damaged flap gate. (O. Magana - DWR UCIP)10/02/2013 Flapgate missing or buried on WS toe. Pipe partially blocked by soil on WS toe. (W. Wylie - DWR UCIP) FIELD_STRUCT_DESC: 24-inch corrugated metal drainage pipe through the levee, 7 feet below the crown. Flap gate located on the waterside (WS) end. A 5-foot by 5-foot concrete control structure located on the landside (LS) toe. [Additional Reference(s): DWR Levee Log, 1992. USACE Sacramento O&M Manual Unit 509, March 1957, As-built drawing no. 50-4-2394 (Station 176+10)]. FS Date: 5/14/2019 4:05:54 PM

Concrete outfall structure at LS toe and irrigation canal

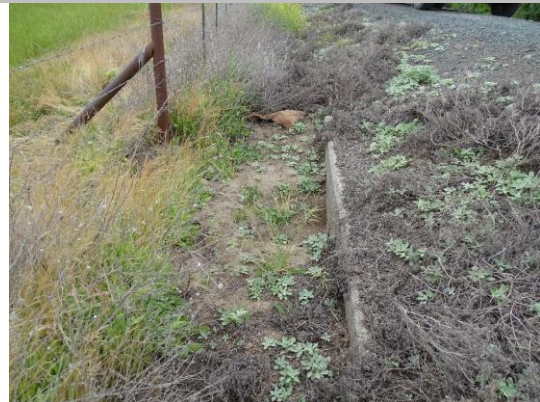
Photo 1 of 3 : UCIP_SP_2019_54011_79272.jpg

Comment Code					
Inspector Comment					
FS_ID:54011					
DS_ID:20877					
EP_NO: N/A					
Repair Type: Non-Urgent					
Crossing Status: Found					
UCIP Comments: 05/14/2019 Pipe outlet and headwall were excavated to evaluate pipe condition. Pipe is completely filled with soil that makes impossible to clear it for DMP internal video inspection. Pipe may be rehabilitated under DMP Phase II or removed. Excavated soil was backfilled. (DWR UCIP - OYakimov)Headwall covered with soil. Needs to be cleared at both ends.					
FIELD_STRUCT_DESC: 24-inch corrugated metal pipe through the levee 5-feet below the crown. Calco automatic drainage gate. Originally included in O+M manual (1957). As-built drawings available 50-4-2394.					
FS Date: 5/14/2019 8:37:31 AM

Concrete headwall on LS toe

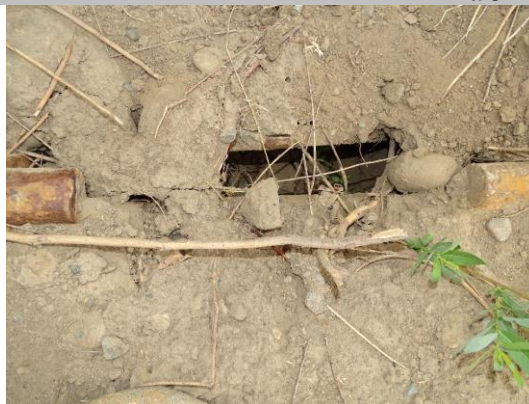
Photo 3 of 3 : UCIP_SP_2019_54011_79274.jpg

Comment Code						
Inspector Comment						
FS_ID:54011 DS_ID:20877 EP_NO: N/A Repair Type: Non-Urgent Crossing Status: Found UCIP Comments: 05/14/2019 Pipe outlet and headwall were excavated to evaluate pipe condition. Pipe is completely filled with soil that makes impossible to clear it for DMP internal video inspection. Pipe may be rehabilitated under DMP Phase II or removed. Excavated soil was backfilled. (DWR UCIP - OYakimov)Headwall covered with soil. Needs to be cleared at both ends. FIELD_STRUCT_DESC: 24-inch corrugated metal pipe through the levee 5-feet below the crown. Calco automatic drainage gate. Originally included in O+M manual (1957). As-built drawings available 50-4-2394. FS Date: 5/14/2019 8:37:31 AM

Pipe outlet discovered at WS toe. Visible gap between flap gate and pipe

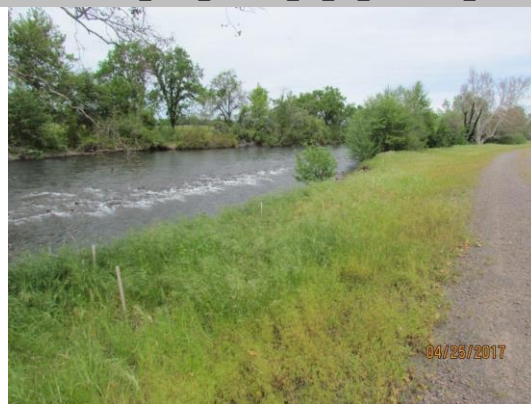
Photo 1 of 1 : SP_2019_NA0019_78_43_20190327_00017.jpg

LM Start	2.75	Rating **	A/W	Issue No.	45	
LM End	2.75	Issue Type +	Ma	Location *		
Category	Supplemental			GPS Latitude/Longitude		
				Start		End
Item	2017 Storm Damage			39.964900 °	39.965030 °	
				-122.029000 °	-122.028700 °	
DWR ID	DWR_NA0019_01_f_2017_45					
Comment Code						
Inspector Comment						
Levee Evaluation Comments						
Description:						
Site ID No:271						
Site Designation:LMA-72						
Repair Type: Erosion						
Rating:Serious						
Field Date:6/6/2017						
Notes:

View of erosion along waterside toe.

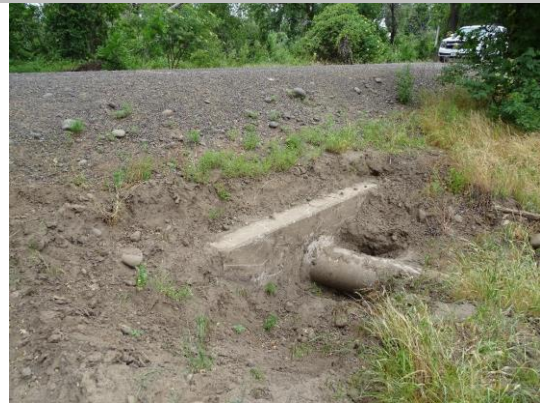
Photo 1 of 3 : UCIP_SP_2019_54012_79276.jpg

Comment Code					
Inspector Comment					
FS_ID:54012 DS_ID:20767 EP_NO: N/A Repair Type: Non-Urgent Crossing Status: Found UCIP Comments: 05/14/2019 Pipe outlet and headwall were excavated to evaluate pipe condition. Discovered a concrete pipe that connects nearby ditch with inlet of this crossing to drain water from the ditch. Cleared pipe outlet at WS toe. (DWR UCIP - OYakimov) Pipe blocked by soil. FIELD_STRUCT_DESC: 24-inch corrugated metal drainage pipe through the levee, 6 feet below the crown. Flap gate on the waterside (WS) end. [Additional Reference(s): DWR Levee Log, 1992. USACE Sacramento O&M Manual 509, March 1957, (Assumed Station 137+50) Drawing No. 50-4-2394]. FS Date: 5/14/2019 9:02:19 AM

Headwal and concrete pipe at LS toe

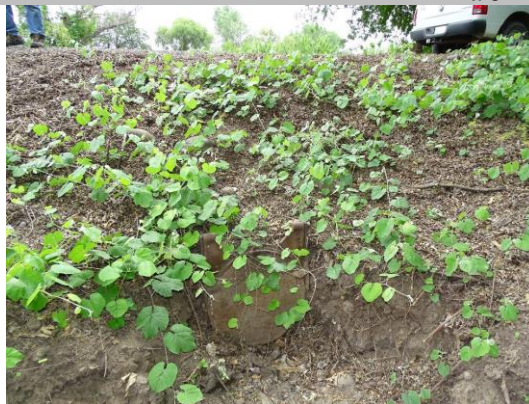
Photo 3 of 3 : UCIP_SP_2019_54012_79278.jpg

Comment Code						
Inspector Comment						
FS_ID:54012 DS_ID:20767 EP_NO: N/A Repair Type: Non-Urgent Crossing Status: Found UCIP Comments: 05/14/2019 Pipe outlet and headwall were excavated to evaluate pipe condition. Discovered a concrete pipe that connects nearby ditch with inlet of this crossing to drain water from the ditch. Cleared pipe outlet at WS toe. (DWR UCIP - OYakimov) Pipe blocked by soil. FIELD_STRUCT_DESC: 24-inch corrugated metal drainage pipe through the levee, 6 feet below the crown. Flap gate on the waterside (WS) end. [Additional Reference(s): DWR Levee Log, 1992. USACE Sacramento O&M Manual 509, March 1957, (Assumed Station 137+50) Drawing No. 50-4-2394]. FS Date: 5/14/2019 9:02:19 AM

Pipe outlet with flap gate at WS toe

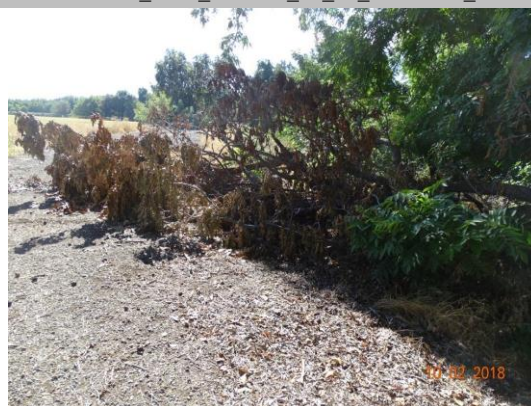
Photo 1 of 1 : SP_2019_NA0019_78_44_20190327_00018.jpg

View of the tree limb along the waterside slope.

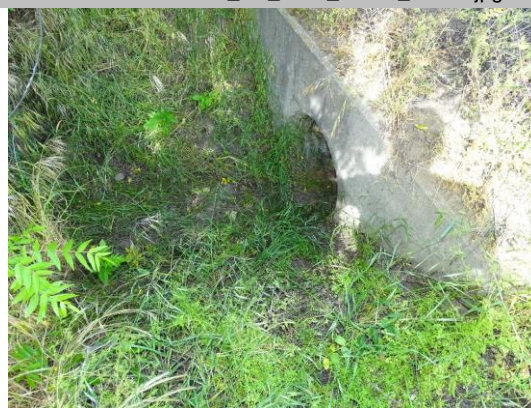
Photo 1 of 3 : UCIP_SP_2019_54023_79298.jpg

LM Start	4.03	Rating **	M	Issue No.	302
LM End	4.03	Issue Type +	Ma	Location *	
Category	Supplemental			GPS Latitude/Longitude	
				Start	End
Item	DWR UCIP LMA Responsibility			39.941574 °	39.941574 °
				-122.057597 °	-122.057597 °
DWR ID	20760				
Comment Code					
Inspector Comment					
FS_ID:54023 DS_ID:20760 EP_NO: N/A Repair Type: Non-Urgent Crossing Status: Found UCIP Comments: 05/14/2019 Crossing is in good condition. (DWR UCIP - OYakimov) FIELD_STRUCT_DESC: 24-inch corrugated metal drainage pipe through the levee, 5 feet below the crown. Flap gate on the waterside (WS) end. Headwalls on both sides of levee. [Additional Reference(s): DWR Levee Log, 1992. USACE Sacramento O&M Manual 509, March 1957, (Assumed Station 5+00) Drawing No. 50-4-2394]. FS Date: 5/14/2019 10:53:58 AM

Headwall and pipe inlet at LS toe

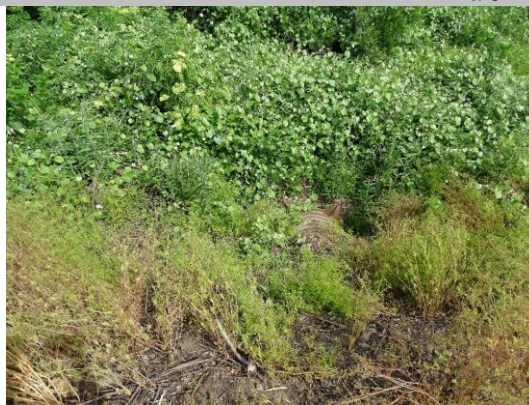
Photo 3 of 3 : UCIP_SP_2019_54023_79300.jpg

LM Start	4.03	Rating **	M	Issue No.	302 (cont)	
LM End	4.03	Issue Type +	Ma	Location *		
Category	Supplemental			GPS Latitude/Longitude		
				Start	End	
Item	DWR UCIP LMA Responsibility			39.941574 °	39.941574 °	
				-122.057597 °	-122.057597 °	
DWR ID	20760					
Comment Code						
Inspector Comment						
FS_ID:54023 DS_ID:20760 EP_NO: N/A Repair Type: Non-Urgent Crossing Status: Found UCIP Comments: 05/14/2019 Crossing is in good condition. (DWR UCIP - OYakimov) FIELD_STRUCT_DESC: 24-inch corrugated metal drainage pipe through the levee, 5 feet below the crown. Flap gate on the waterside (WS) end. Headwalls on both sides of levee. [Additional Reference(s): DWR Levee Log, 1992. USACE Sacramento O&M Manual 509, March 1957, (Assumed Station 5+00) Drawing No. 50-4-2394]. FS Date: 5/14/2019 10:53:58 AM

Pipe ang flap gate at WS slope

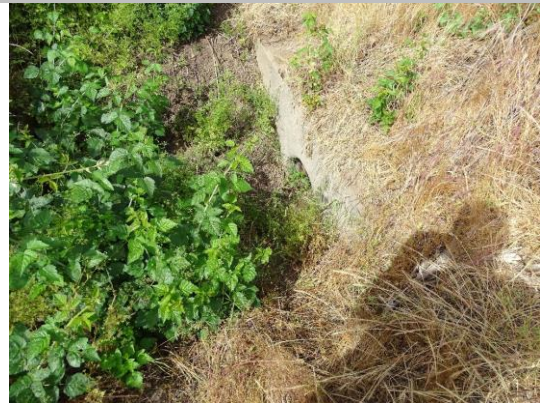
Photo 1 of 3 : UCIP_SP_2019_54024_79304.jpg

Comment Code					
Inspector Comment					
FS_ID:54024 DS_ID:20762 EP_NO: N/A Repair Type: Urgent Crossing Status: Found UCIP Comments: 05/14/2019 Missing flap gate, pipe outlet is silted. (DWR UCIP - OYakimov)10/15/2018 Missing flap gate at WS end of the pipe. Pipe is partially blocked with silt. Updated coordinates and CLM. (O.Yakimov - DWR)12/05/2016 unable to complete inspection -- unable to locate. (O. Magana - DWR UCIP)10/03/2013 Gate missing from WS toe. (W. Wylie - DWR UCIP) FIELD_STRUCT_DESC: 24-inch corrugated metal drainage pipe through the levee, 5.5 feet below the crown. Flap gate located on the waterside (WS) end. Concrete headwall located on the landside (LS) toe. [Additional Reference(s): DWR Levee Log, 1992. USACE Sacramento O&M Manual Unit 509, March 1957, As-built drawing no. 50-4-2394 (Station 0+65)]. FS Date: 5/14/2019 11:01:16 AM

Headwall and inlet at LS toe

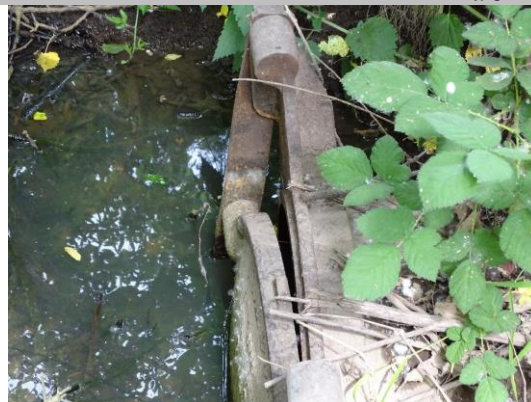
Photo 3 of 3 : UCIP_SP_2019_53997_79238.jpg

Flapgate gap due to sediment buildup at the bottom of pipe

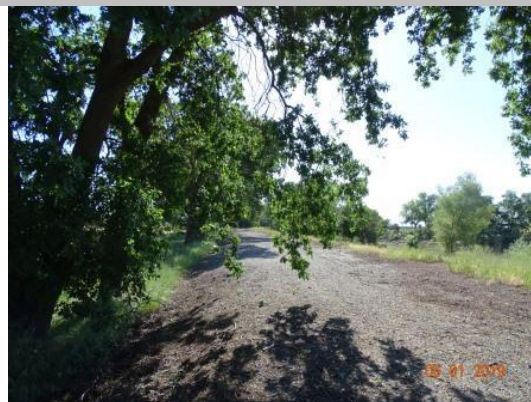
Photo 1 of 1 : SP_2019_NA0019_81_53_20190506_00079.jpg

View of the tree branches hanging over the crown. Spring 2019.

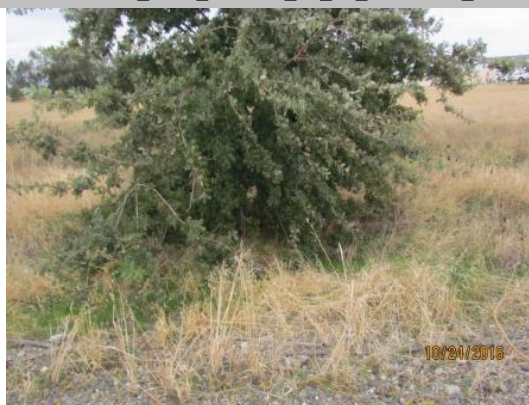
Photo 1 of 1 : SP_2019_NA0019_81_13_20190327_00008.jpg

View of a tree with overhanging branches.

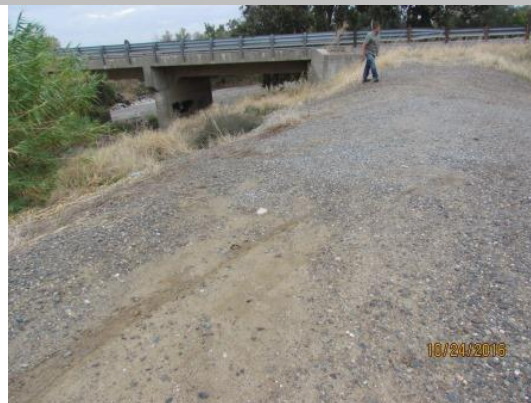
Photo 1 of 1 : SP_2019_NA0019_81_27_20190327_00015.jpg

View of the slope instability caused by vehicles.

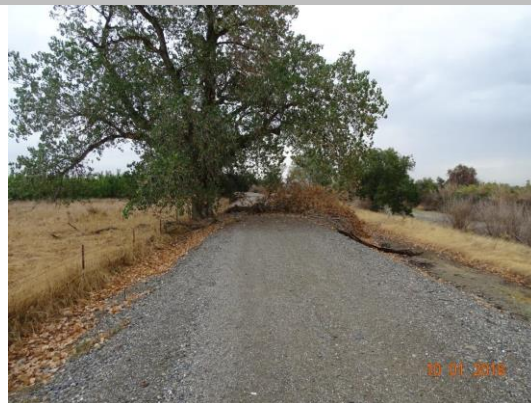
Photo 1 of 1 : SP_2019_NA0019_81_48_20190327_00022.jpg

View of the tree limb that is fallen on the crown roadway.

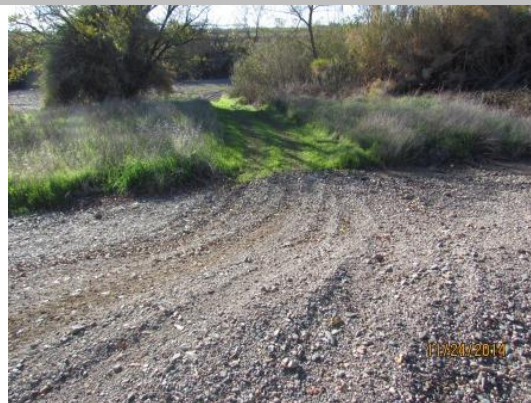
Photo 1 of 1 : SP_2019_NA0019_81_16_20190327_00011.jpg

View of the slope instability caused by vehicles along the waterside slope.

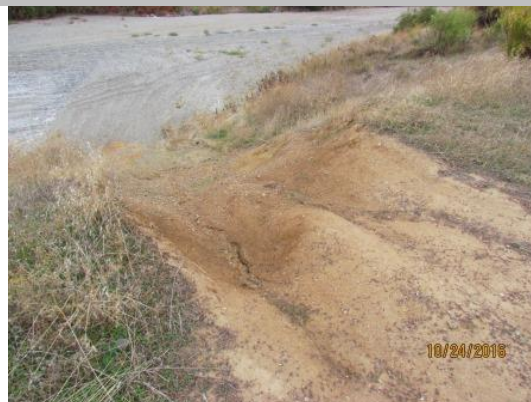
Photo 1 of 1 : SP_2019_NA0019_81_29_20190327_00016.jpg

View of the slope instability caused by vehicles along the waterside slope.

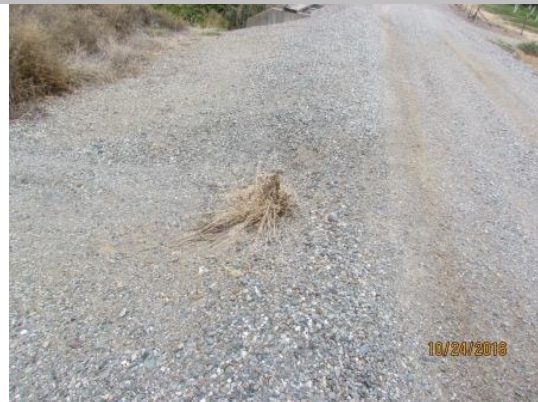
Photo 1 of 2 : SP_2019_NA0019_81_3_20190327_00003.jpg

View of a dip along the levee slope.

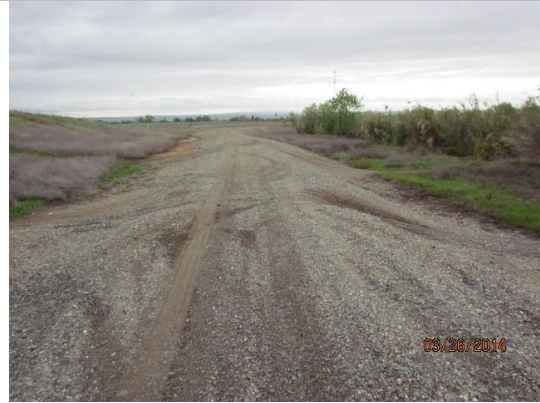
Photo 2 of 2 : SP_2019_NA0019_81_3_20190327_00004.jpg

View of the levee slope damaged by vehicle traffic.

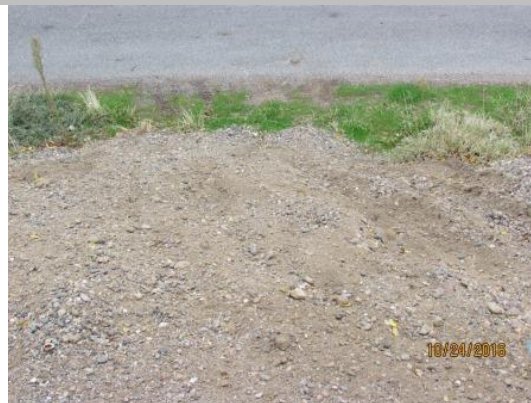
Photo 1 of 1 : SP_2019_NA0019_81_30_20190327_00017.jpg

View of the slope instability caused by vehicles along the landside slope.

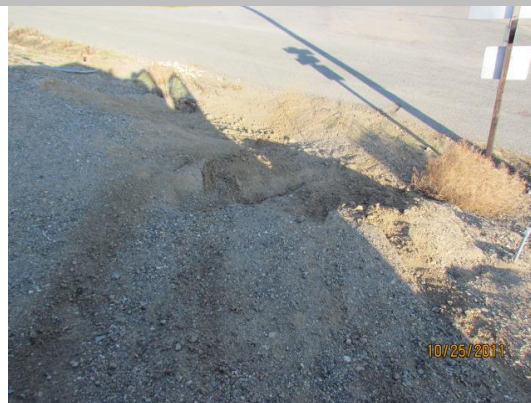
Photo 1 of 1 : SP_2019_NA0019_81_20_20190327_00012.jpg

View of the slope instability caused by vehicles along the landside slope.

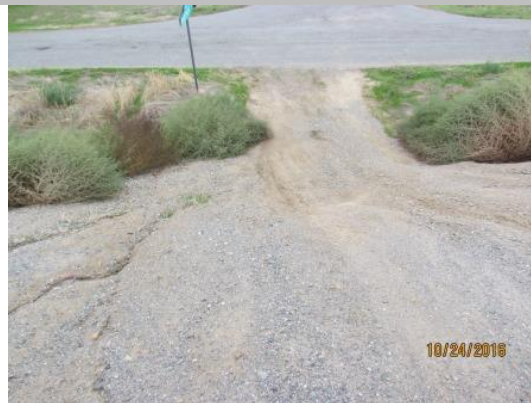
Photo 1 of 1 : SP_2019_NA0019_81_2_20190327_00002.jpg

View of the slope instability caused by vehicles along the landside slope.

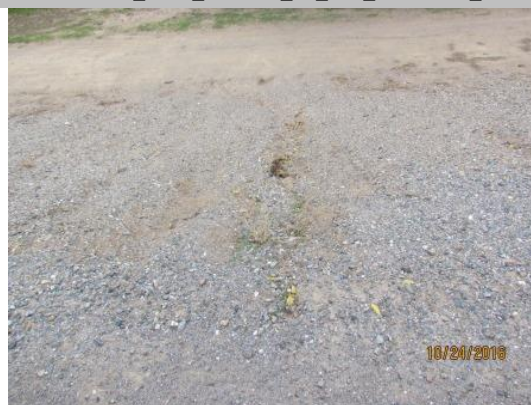
Photo 1 of 1 : SP_2019_NA0019_81_916_20190327_00025.jpg

View of the slope instability caused by vehicles along the waterside slope.

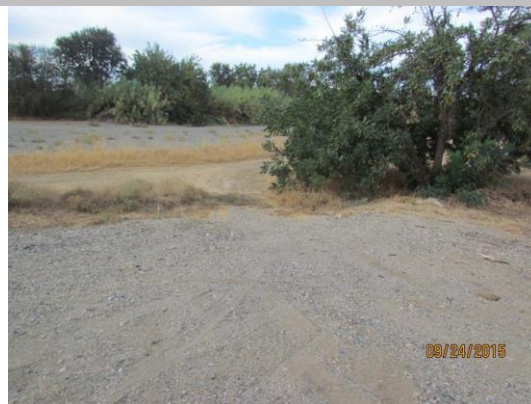
Photo 1 of 1 : SP_2019_NA0019_81_10_20190327_00006.jpg

View of the slope instability caused by vehicles along the waterside slope.

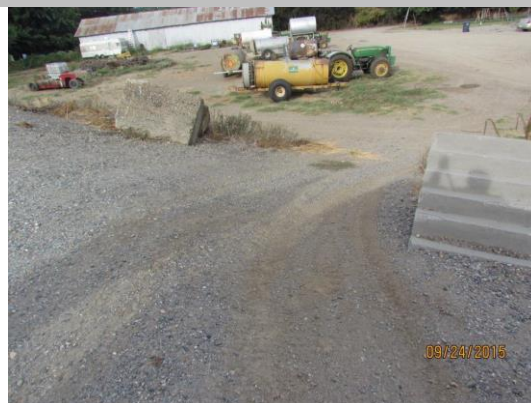
Photo 1 of 1 : SP_2019_NA0019_81_25_20190327_00014.jpg

View of the slope instability caused by vehicles along the landside slope.

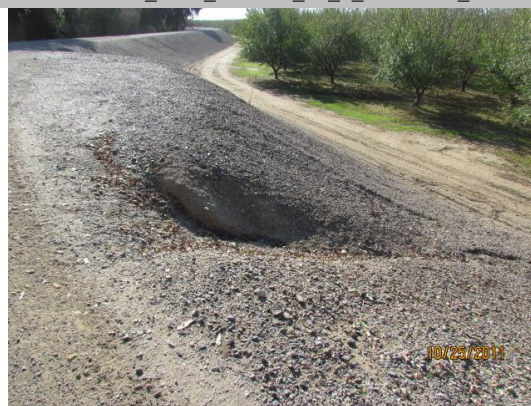
Photo 1 of 1 : SP_2019_NA0019_82_7_20190327_00002.jpg

View of the erosion along the landside slope.

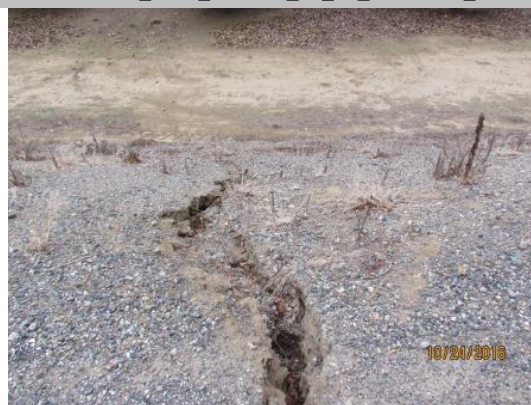
Photo 1 of 1 : SP_2019_NA0019_82_19_20190327_00007.jpg

View of the erosion along the landside slope.

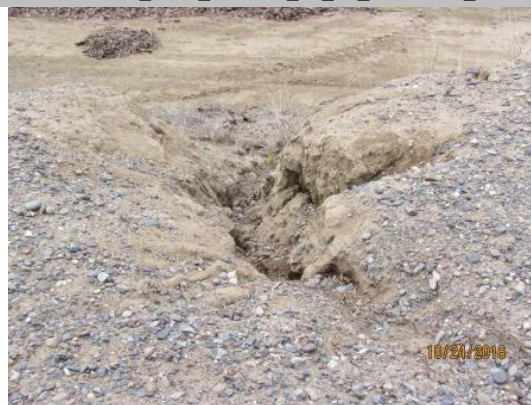
Photo 1 of 1 : SP_2019_NA0019_82_18_20190327_00006.jpg

View of the erosion along the landside slope.
